17<sup>th</sup> INTERNATIONAL SHIP AND  
OFFSHORE STRUCTURES CONGRESS  
16-21 AUGUST 2009  
SEOUL, KOREA

**COMMITTEE V.1  
DAMAGE ASSESSMENT  
AFTER ACCIDENTAL EVENTS**

**COMMITTEE MANDATE**

Concern for the extent of damage and local and global residual strength of ship structures, after accidental events. Such damage is to be the result from small and large energy events such as wave impact, green water, slamming, dropped and impacting objects, local overload, collision, grounding, explosions, fire and similar. The assessment shall be conducted in both the absence and presence of ageing effects such as fatigue cracks, corrosion and local dents. The assessment shall also include the effects of temporary repairs and mitigating actions following the damage.

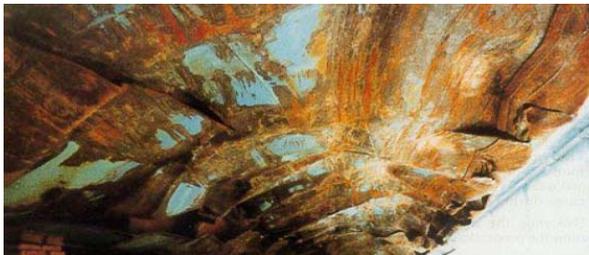
Figure 5: El Paso Paul Kayser

A common loading pattern when a ship runs with forward speed on the sea bed is a contact force distribution, which is oblique with respect to the plane of the bottom shell. The figures of the damaged hulls of Sea Empress and El Paso Paul Kayser reveal that the shell of the vessels were subject to such type of loading while they were moving forward in contact with rocks. In the case of Sea Empress the side shell has been removed from the action of the rock, while in the case of El Paso Paul Kayser it appears that the side shell was pushed inside the double bottom space, as shown in Figures 5 and 6, (Weverscove 2008).
